March 8, 2021
Assessment & Results Report:
Property Assessed:

Air Quality Testing
Dharma Centre of Canada – 1267 Galway Rd. Kinmount ON

Air Quality Testing

Dharma Centre of Canada – 1267 Galway Rd. Kinmount ON

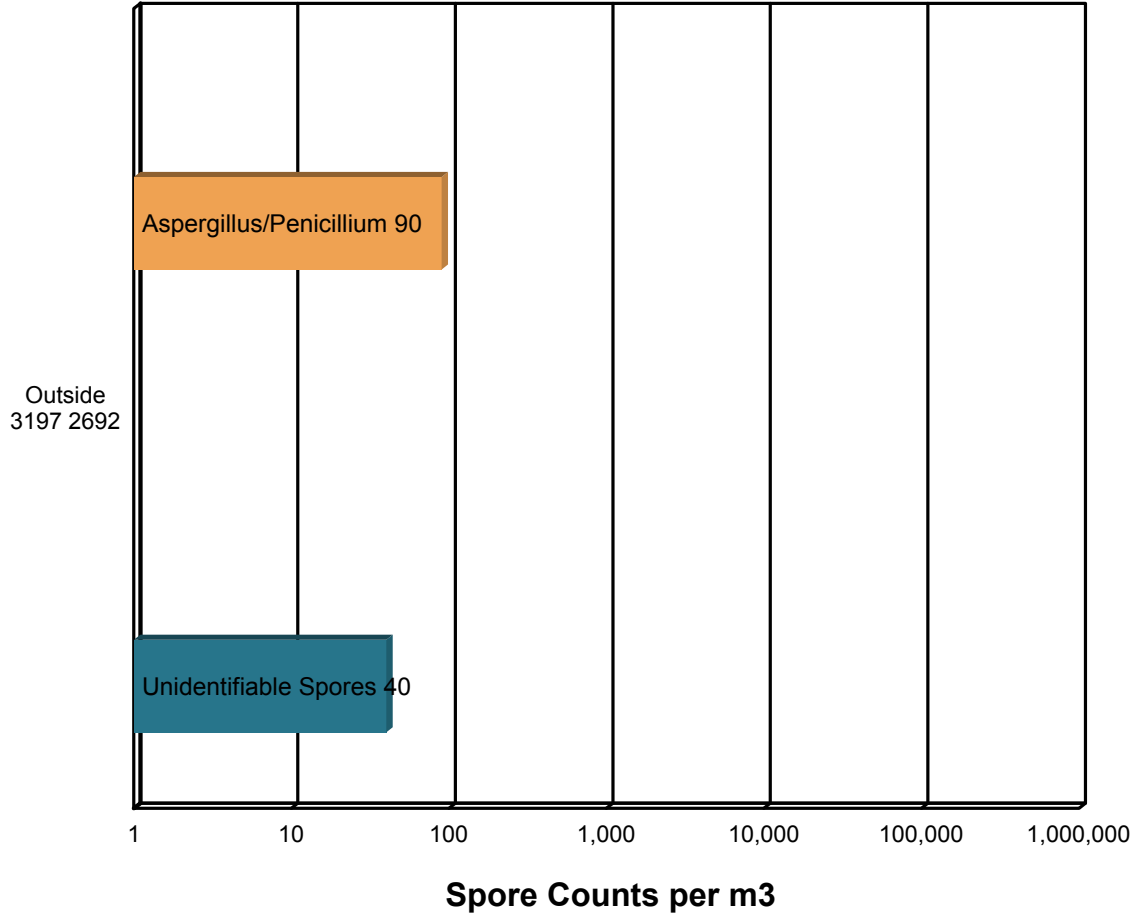
Spore Trap Report: Total Counts

■ Ascospores	■ Aspergillus/Penicillium	■ Basidiospores	■ Cladosporium
■ Myxomycetes++	■ Pithomyces++	■ Unidentifiable Spores

* The chart is displayed using a logarithmic scale. Bar size is not directly proportional to the number of spores.

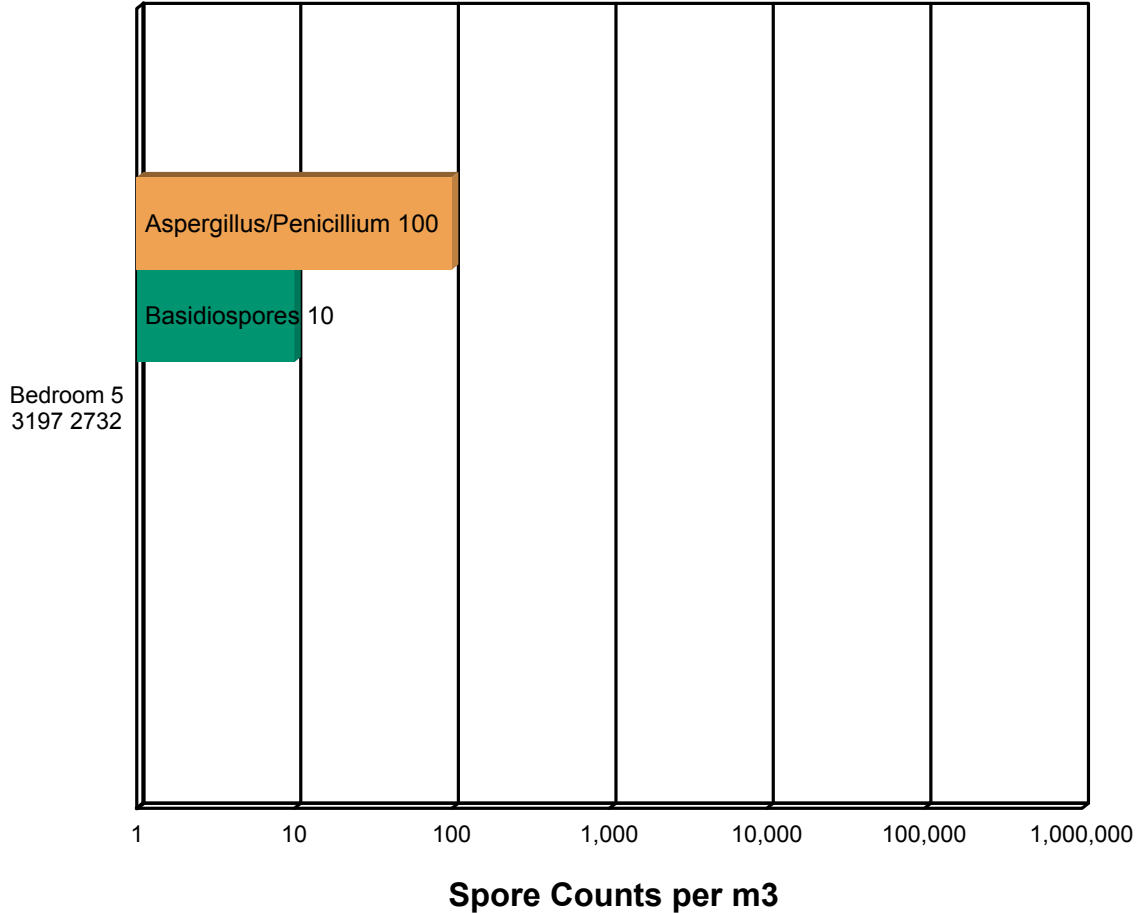
Spore Trap Report: Total Counts

■ Ascospores	■ Aspergillus/Penicillium	■ Basidiospores	■ Cladosporium
■ Myxomycetes++	■ Pithomyces++	■ Unidentifiable Spores

* The chart is displayed using a logarithmic scale. Bar size is not directly proportional to the number of spores.

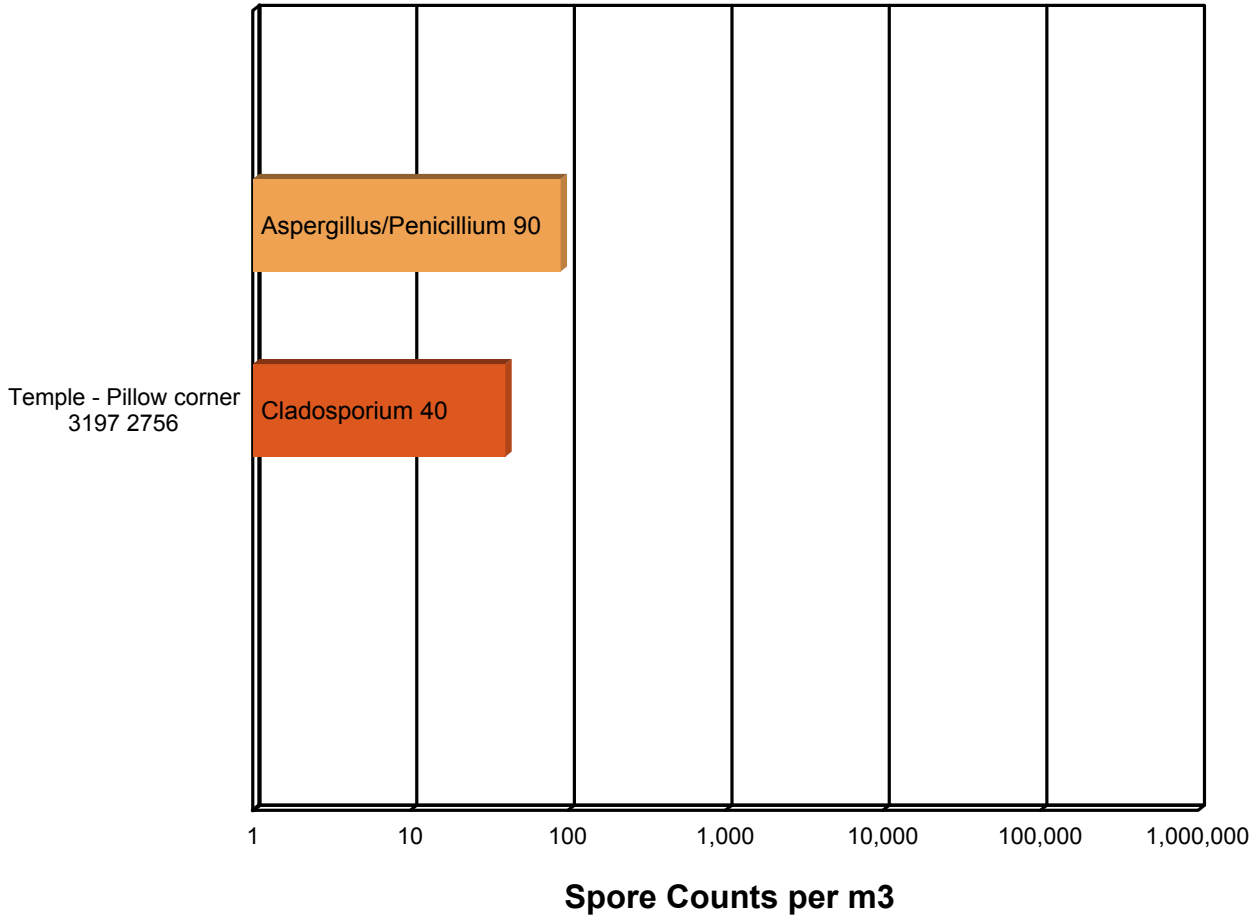
Spore Trap Report: Total Counts

Ascospores	Aspergillus/Penicillium	Basidiospores	Cladosporium
Myxomycetes++	Pithomyces++	Unidentifiable Spores

* The chart is displayed using a logarithmic scale. Bar size is not directly proportional to the number of spores.
